GEO-FORENSICS —
LESSONS LEARNED
FROM FAILURES

In the Wake of the Mount Polley Mine Tailings Breach

Tailings Dam Design, Innovation, and Practice Changes

By Harvey N. McLeod, P.Eng., P.Geo.

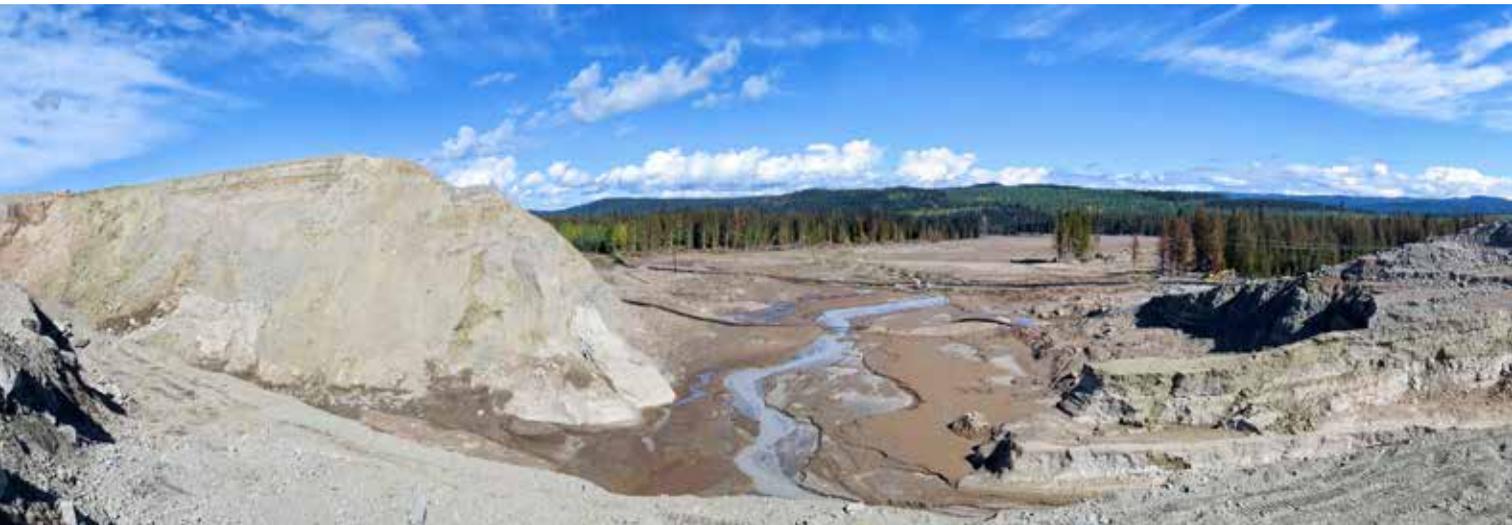
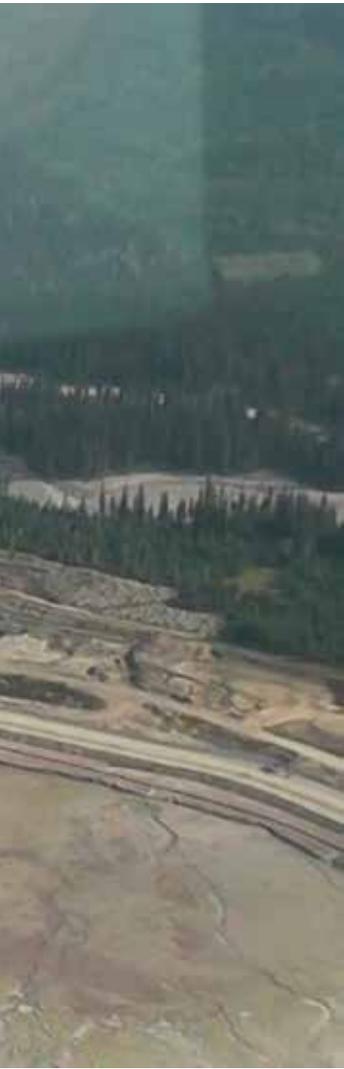
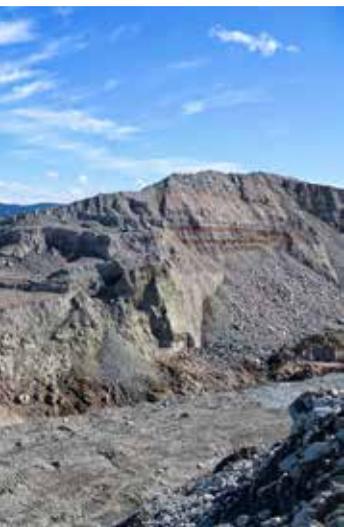
Mt. Polley dam failure. (Top Photo: Reuters.)

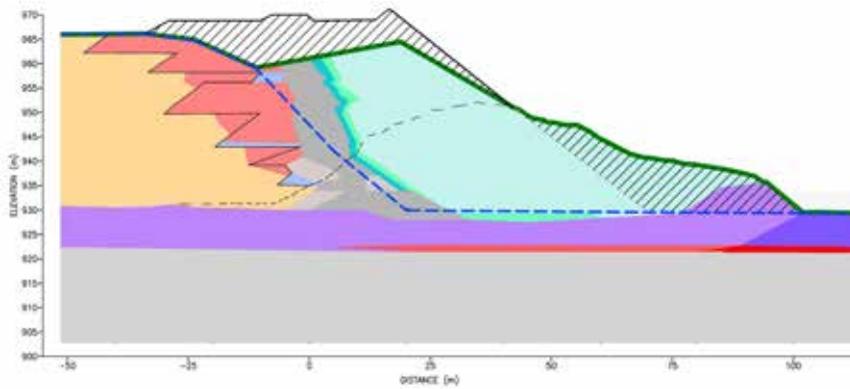
Figure 1. Section showing “slump” of Mt. Polley dam prior to the overtopping erosion/failure.

The Mt. Polley dam failed because of an unidentified glacial clay layer

that caused the dam to “slump” (i.e., the dam crest dropped approximately 3-5 m as depicted in Figure 1). This slumping allowed the impounded water to flow over the crest of the dam, initially very slowly. However, within approximately 1½ hours, the flow rate continued to increase and eventually led to catastrophic release of water and tailings.

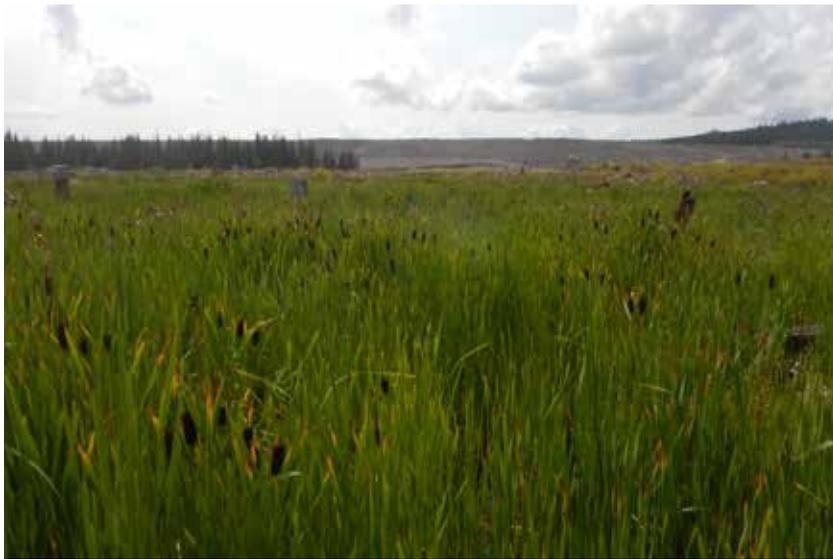
Figure 2. Rehabilitation with constructed habitat wetland in Hazeltime Creek. (Photo: Mount Polley Mining Corp.)

Canada. Since the failure, progress has been made on rehabilitating the impacted areas: more than 500,000 native trees and shrubs were planted, 3+ km of new trout-spawning and rearing habitat were created, and Hazeltime Creek was reconstructed to control erosion of the residual tailings with channel bank re-sloping and placement of erosion-control materials. Monitoring of the water quality in Quesnel Lake indicates that the deposited tailings are physically and chemically stable and are not releasing metals into the lake. Overall, the terrestrial and aquatic ecosystems are showing positive signs of recovery as shown in Figure 2.

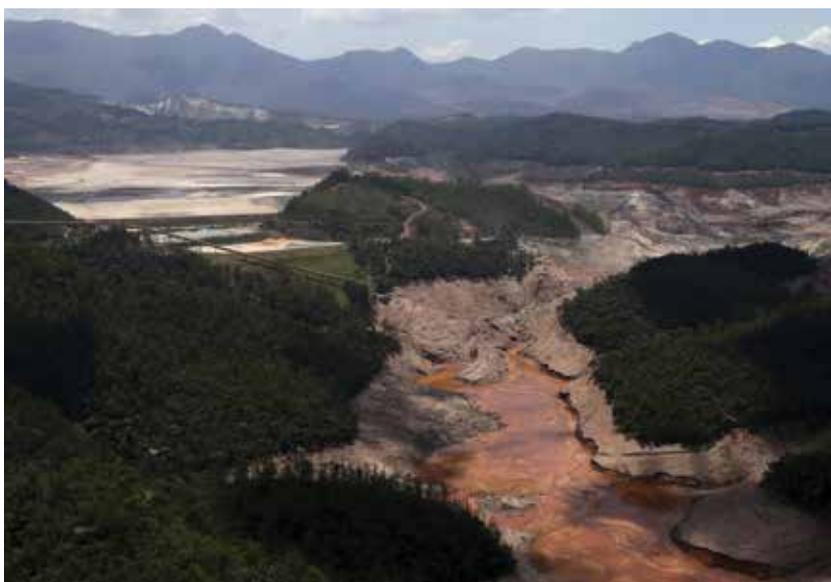
Figure 3. Fundão Dam failure. (Photo: Reuters.)

Since the Mount Polley failure, there have been two tragic, catastrophic failures of tailings dams in Brazil: Samarco's Fundão in 2015 (Figure 3), and Brumadinho in 2019 (Figure 4). Both dams were constructed

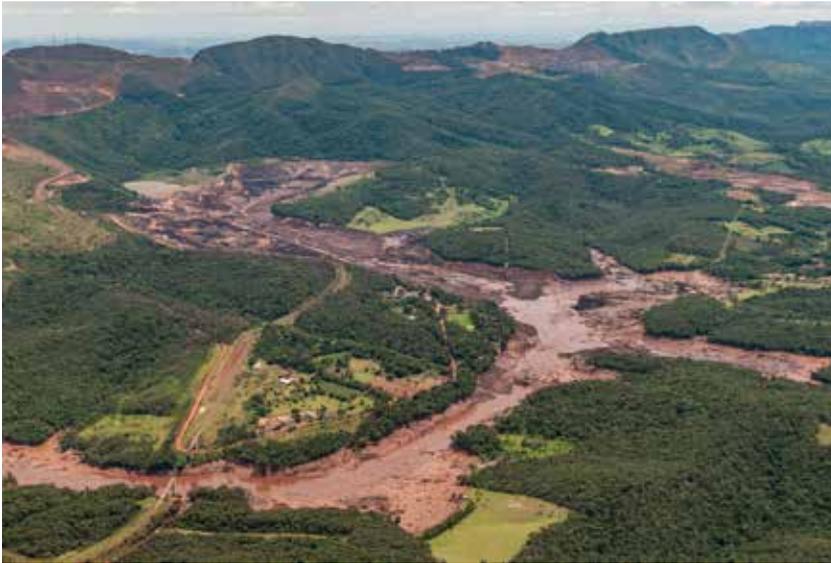
Figure 4. Brumadinho Dam failure. (Photo: Wikipedia.)

The most recent Brumadinho failure in Brazil (Figure 4) precipitated the initiation of a Global Tailings Review (GTR), which aims to develop a global standard for tailings dams. The GTR is supported by the International ICMM, the United Nations Environment Program (UNEP), and the Principles of Responsible Investment (PRI), the members of which, including the Church of England and the Swedish Pension Funds, have over 10 trillion U.S. dollars invested in the mining industry. The standard is in the consultation phase, which has included public presentations and industry meetings in numerous countries and an online, Internet-based forum for gathering and collating comments on the standard.

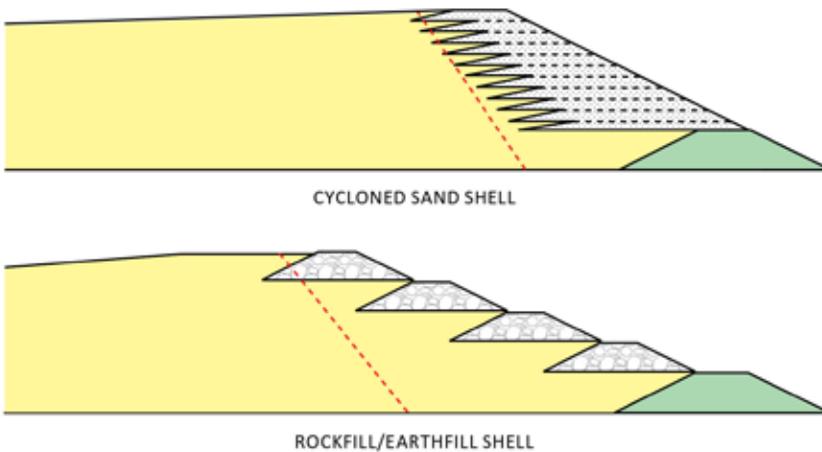
Figure 5. Schematic of upstream construction method.

by applying variations of the upstream construction method, depicted in Figure 5. Trapezoidal embankments are constructed on top, toe to crest of each other, as the tailings are deposited, and the crest migrates further upstream. This method of construction relies on the strength of uncompacted tailings for support because the dam is constructed overtop previously deposited tailings.
